COVENTRY P.E.A.C.E CAMPUS (SCHOOL BUILDING)

**Facility Assessment
2843 Washington Blvd.
Cleveland Heights, OH 44118**

Prepared by IFF

July 2019

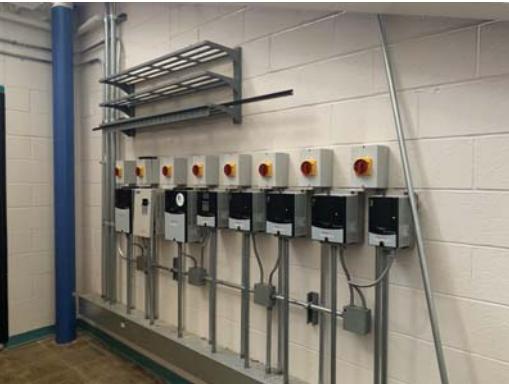
HVAC controls - Room 212

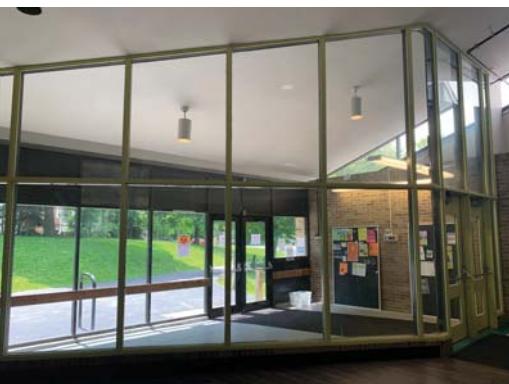
Lobby entrance - glass wall

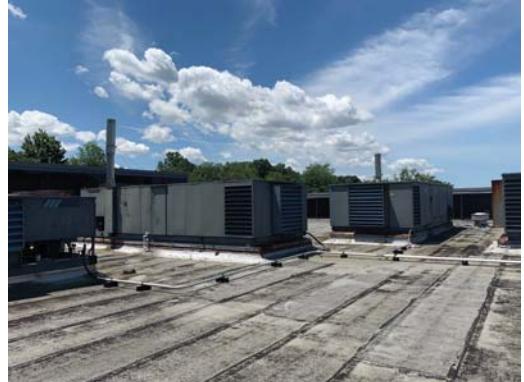
Condensate lines on the rooftop units tend to back up and this could lead to ponding on the roof causing leaks, it is imperative to inspect and clear any stoppages that may occur. This problem occurred recently and was corrected by the maintenance staff.

HVAC rooftop units

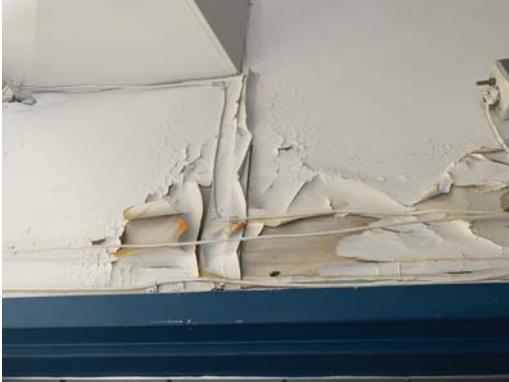
Room 212 - peeling paint

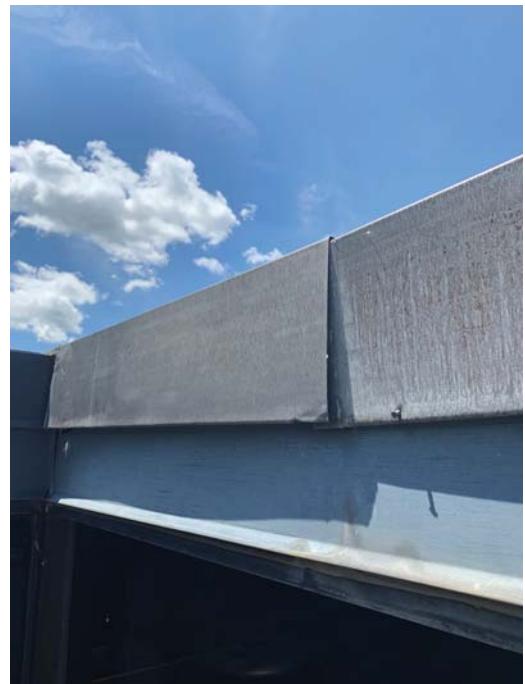
Parapet - metal trim

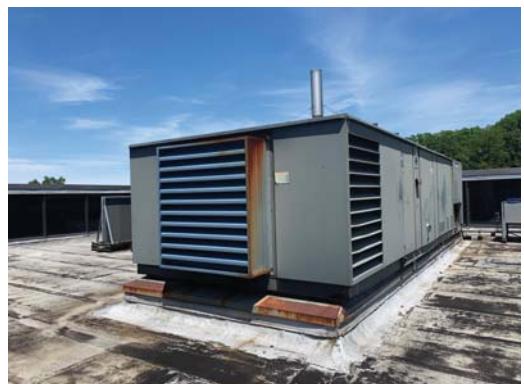
A rooftop compressor feeding gym/theatre has had some problems. In the short-term, controls that are exposed on the unit should be repaired/replaced, this will extend the life of the unit for an undetermined amount of time. Long-term replacement of the compressor is recommended.

Rooftop HVAC unit

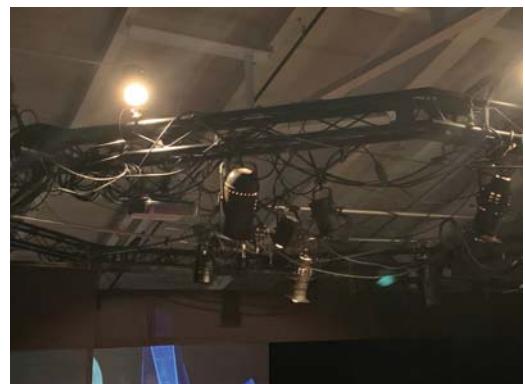
Theatre lighting

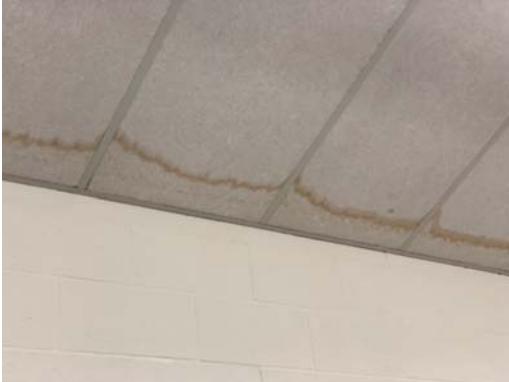
Ceiling tile water damage

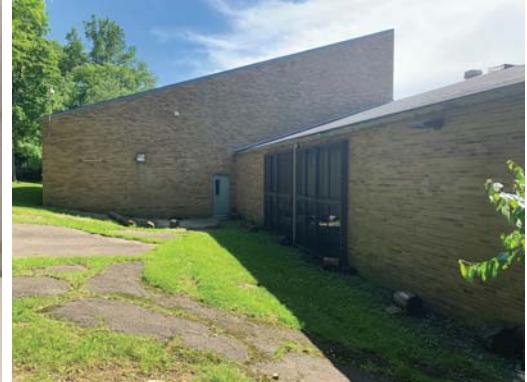
Exterior slope in rear - ponding

- Lighting upgrades, including theatre
- Re-grade exterior (behind theatre areas) to provide proper drainage of paved section, as currently graded water has ponded and created water infiltration beneath doors.
- Repair rooftop compressor above gym/theatre
- Interior buildout of vacant spaces
- New interior doors, allowance

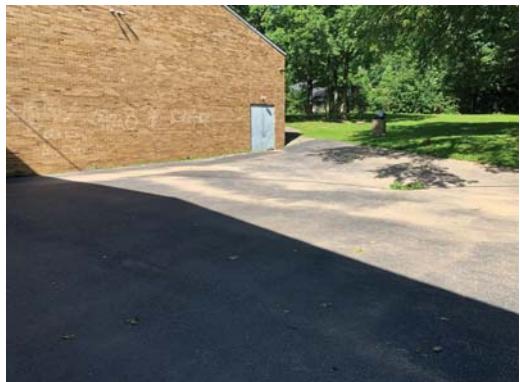
Exterior ponding area

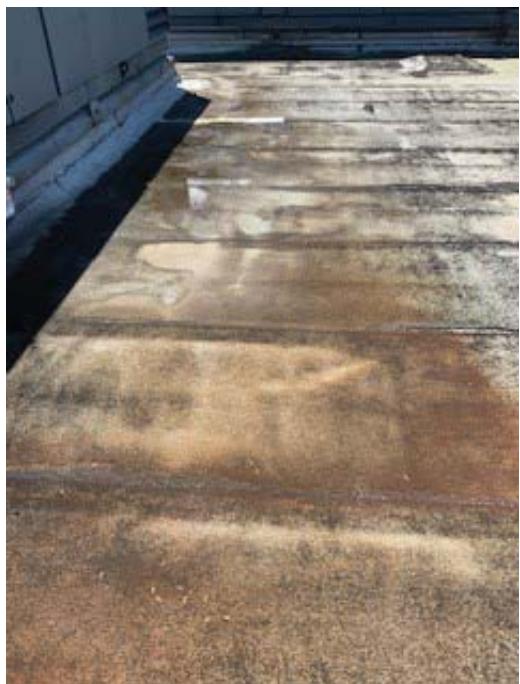
1. Flat section which covers the center of the facility has a built-up roofing system (BUR -Tar/asphalt) which shows signs of leakage at multiple locations and is currently in need of repair.
2. The section of materials covering a portion of the facility to the south (rooms #103/104/105) is covered with metal roof panels that are in average condition with no visible signs of disrepair.
3. Commercial grade asphalt shingles covers the remainder of the building, these sections show normal wear.

Roof

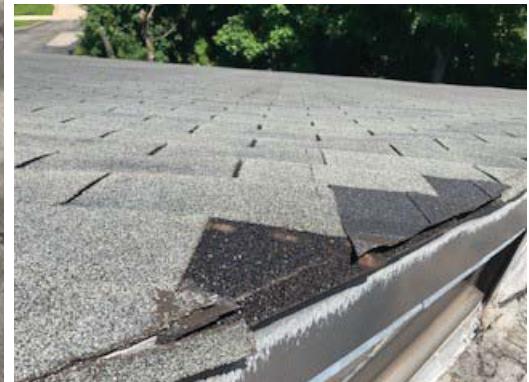
Roof - damaged shingles

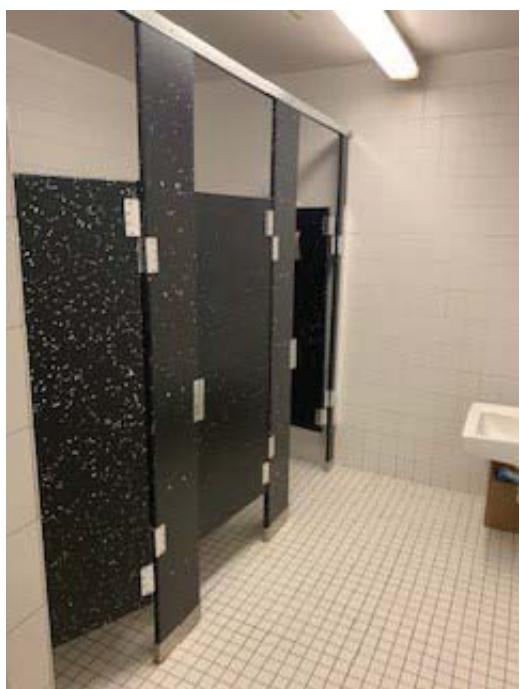
Restrooms: Lower level and Second floor restrooms do not meet ADA accessibility requirements as currently configured.

Public restroom (typical)

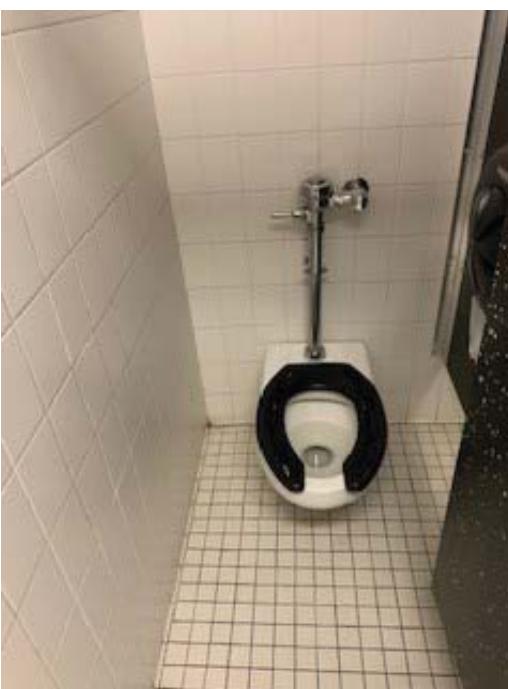
Restroom stall (typical)

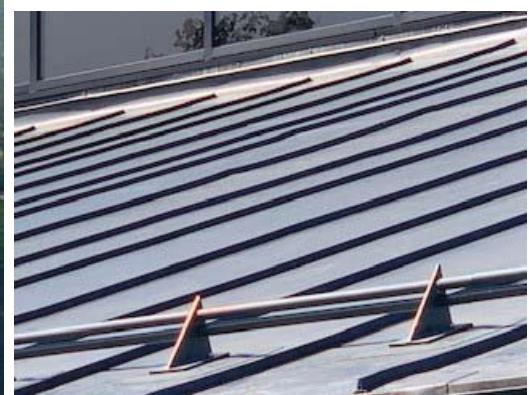
Metal roof
